SUSQUEHANNA RIVER BASIN
NEGLEY DAM
WILBUR R. NEGLEY, JR.

NDI NO. PA-00948
DER NO. 50-061

PHASE I INSPECTION REPORT.
NATIONAL DAM INSPECTION PROGRAM.

Name of Dam: NEGLEY DAM
State & State No.: PENNSYLVANIA, 50-61
County: PERRY
Stream: TRIBUTARY TO LITTLE JUNIATA CREEK
Date of Inspection: NOVEMBER 4, 1980

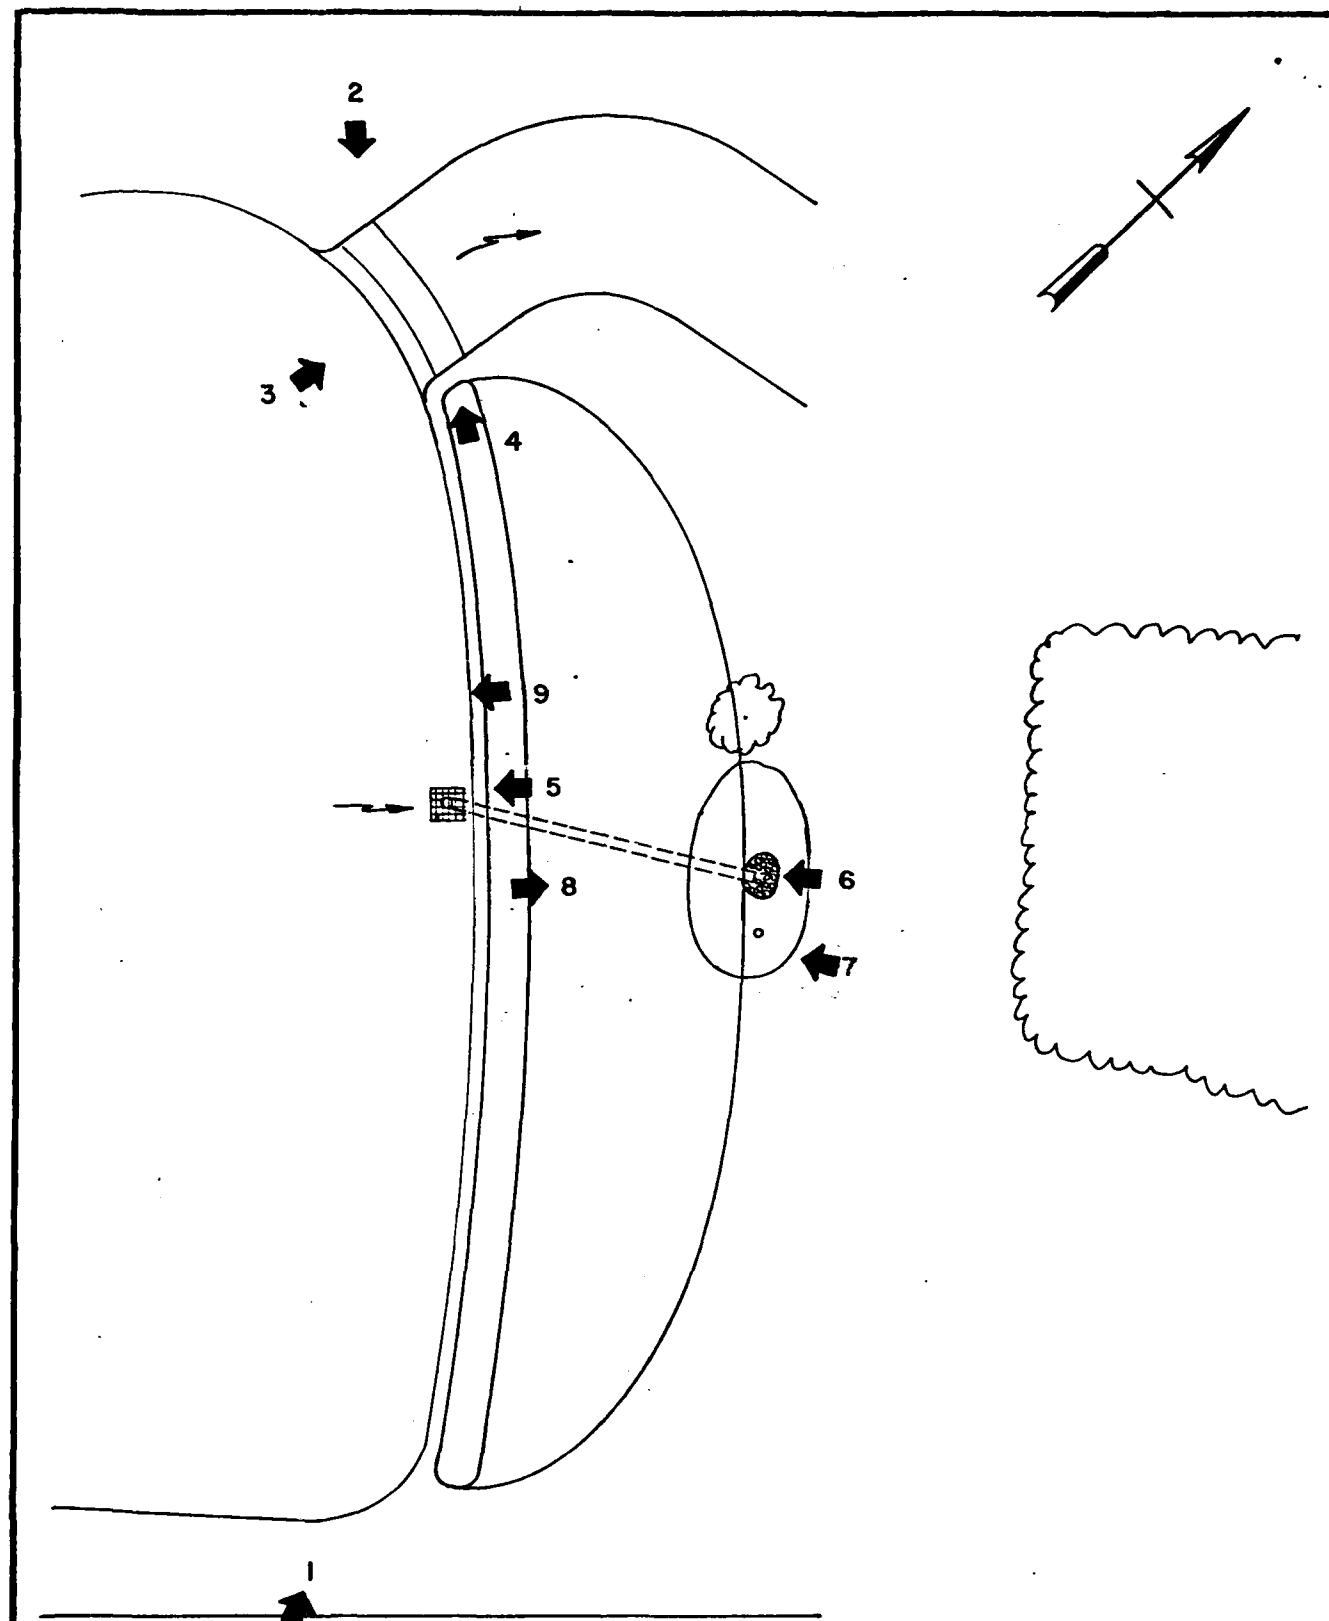
The nineteen foot high embankment is located in an area with gentle slopes. The right abutment is close to a local road which parallels the reservoir. The slopes of the embankment and the crest of the dam have a well maintained grass mat. There were no indications of surface cracks, sloughing or other signs of an unstable condition. An area at the downstream toe around the outlets of the drawdown pipe and the principal spillway was wet and soggy with some small pools of standing water. Water movement was small and not measurable. Weeds and briars prevented close observation of this condition. At the time of inspection, the reservoir water level was 2.3 feet below normal pool elevation. It is recommended that this wet condition be kept under regular surveillance, especially during high pool levels. A groundhog hole was observed in the overgrown area.

1. That the brush and weeds be removed in the seepage area at the downstream pipe outlet and that this area be maintained on a regular basis.
2. That the seepage condition at the downstream toe be observed on a regular basis. If turbidity or an increase in quantity is detected, immediate steps should be taken to correct the condition.
3. That provisions be made to provide for upstream closure of the drawdown pipe in case of an emergency.
4. That the groundhog hole be filled.
